INSPECTION REPORT

For the Property at:
1234 MAIN ST
KELOWNA, BC

Prepared for: JOHN DOE
Inspection Date: Tuesday, March 11, 2014
Prepared by: Mike Bradshaw

RE: Report No. 1090, v.2
1234 Main St
Kelowna, BC

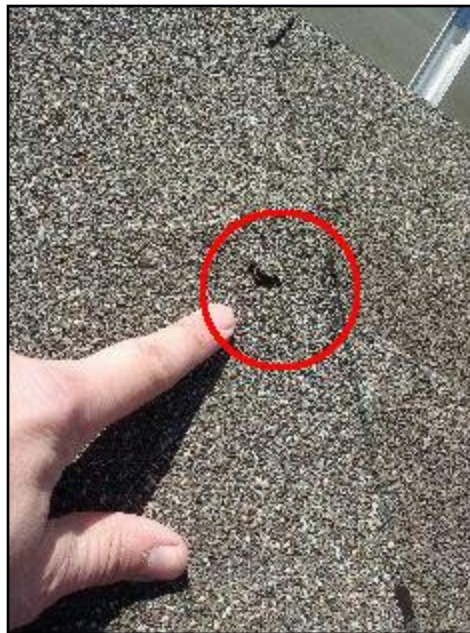
4. *Exposed fasteners*

Noted nail head popping up through asphalt shingle. Recommend repair and sealant added to nail head.

Implication(s): Chance of water damage to contents, finishes and/or structure

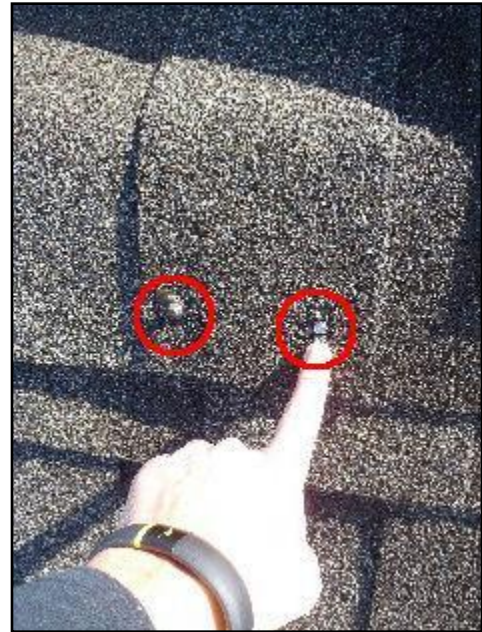
6. Exposed fasteners

Noted exposed screw heads in various locations on the roof, these nail heads should be tabbed with sealant to prevent rusting and leaks in the future.

Implication(s): Chance of water damage to contents, finishes and/or structure

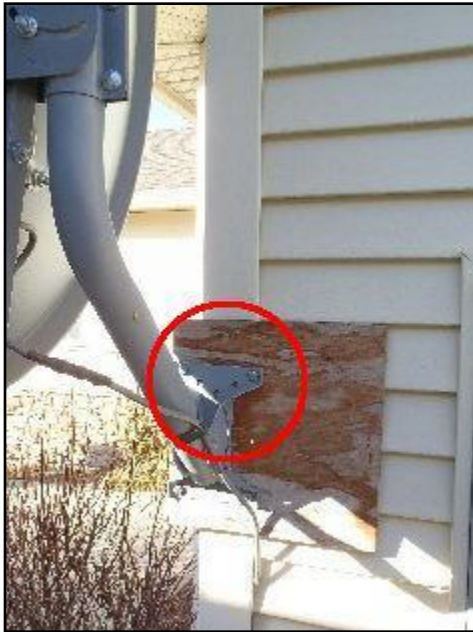
26. Mechanical damage

Noted minor damage to the vinyl siding from mounting of satellite dish. Recommend sealing holes in vinyl siding after dish is removed.

Implication(s): Cosmetic defects | Chance of water damage to contents, finishes and/or structure

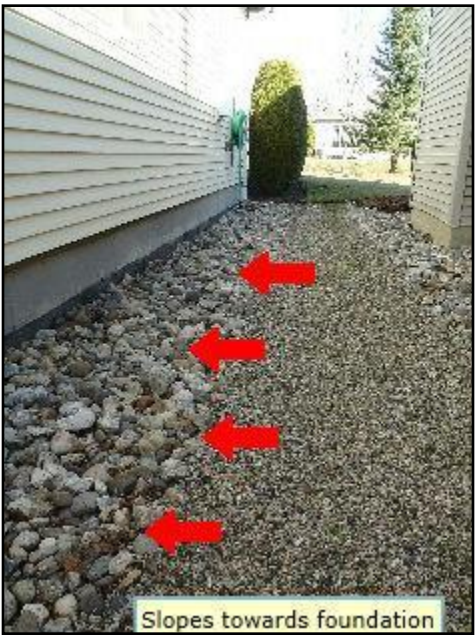
28. Improper slope or drainage

Noted gravel walkway on the right side of the house slopes towards the foundation wall. Recommend sloping the soil against the foundation wall towards the gravel walkway. Crawl space inspection did not find any signs of moisture.

Implication(s): Chance of water damage to contents, finishes and/or structure

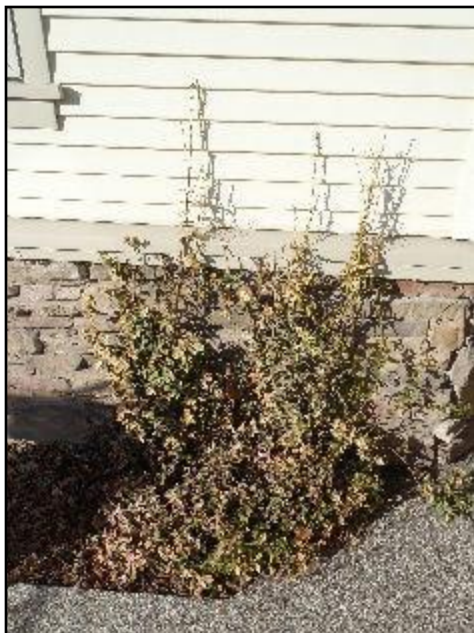
29. Vines on building

Noted vine type plant growing in a few locations along the front of the house. Vines appear to be getting under vinyl siding. Recommend plants be removed or trimmed back to help avoid damage to the exterior siding.

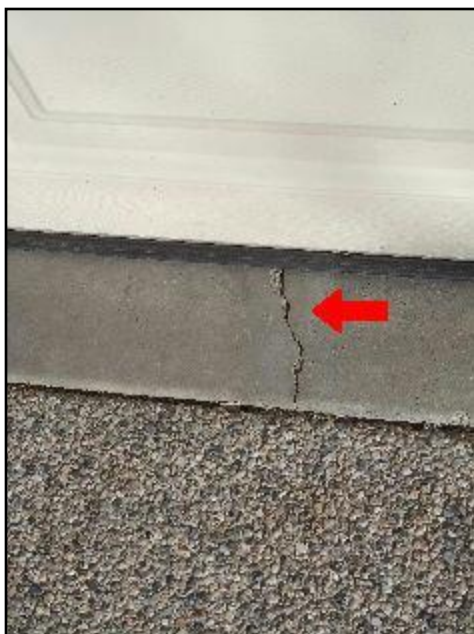
31. Cracked

Noted minor cracking on the concrete floor in the garage. This is typical in concrete slabs. Recommend monitoring for displacement.

Also recommend sealing cracks to help keep water and salt from the vehicle out of the cracks.

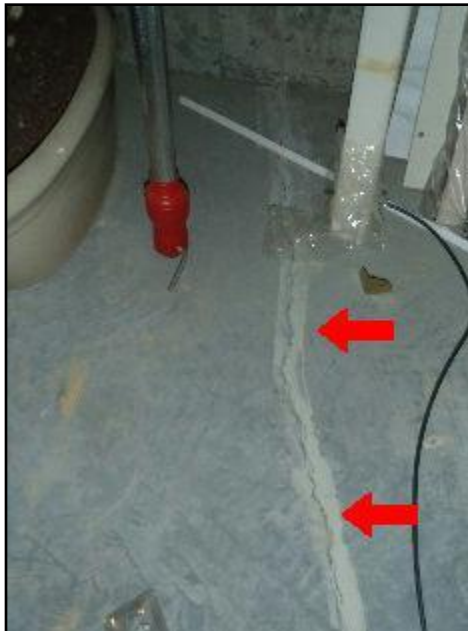
39. Cracked

Noted minor crack in the concrete slab of the crawl space. These are typically found in concrete slabs. Recommend monitoring for displacement. Inspection was impacted due to the many stored items in the crawl space.

Implication(s): Cosmetic defects | Chance of water damage to contents, finishes and/or structure | Trip or fall hazard

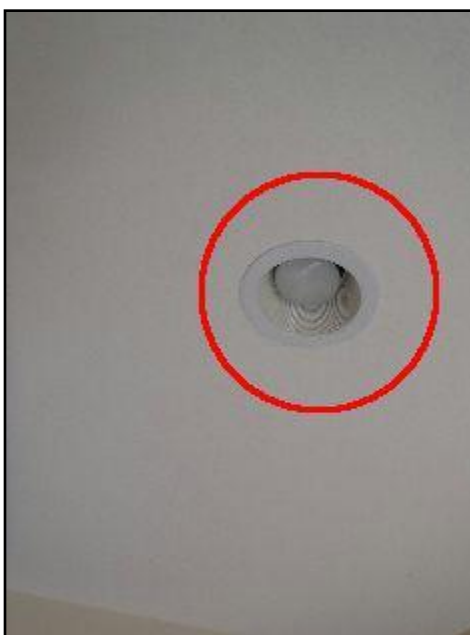
46. Inoperative

Noted light not working in front entry way. Possible light bulb burnt out.

Implication(s): Inadequate lighting

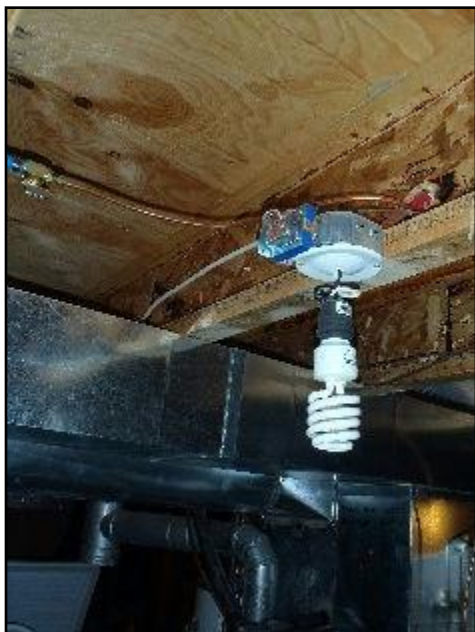
47. Inoperative

Noted a couple of lights not working in the crawl space area. One was in the staircase to crawl space and the other in the crawl space. Light bulbs possibly burnt out. Recommend changing light bulbs.

Implication(s): Inadequate lighting

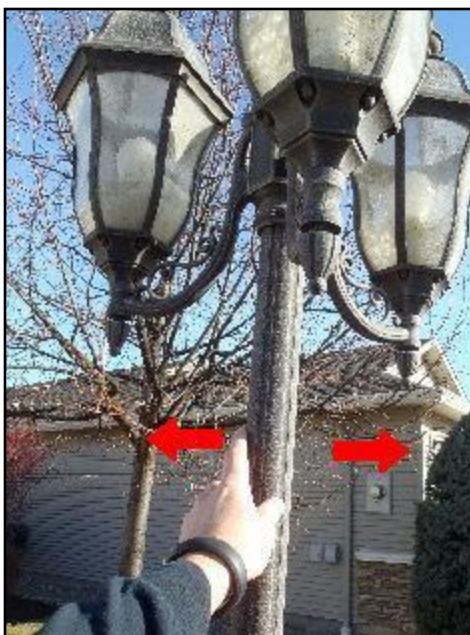
49. Loose

Noted light fixture in the front yard was loose in a couple of places. Recommend tightening.

Implication(s): Electric shock | Fire hazard

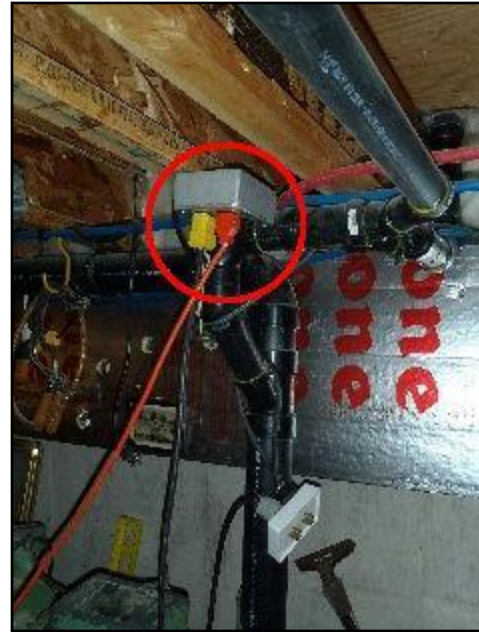
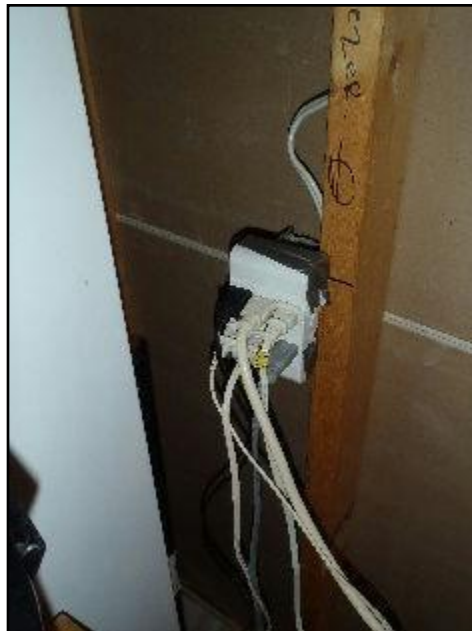
11. Condition: • Noted several outlets in the crawl space that appeared to be overloaded with appliances, fans and heaters plugged into them. Recommend reducing the amount of appliances being used at the same time.

Implication(s): Fire Hazard,

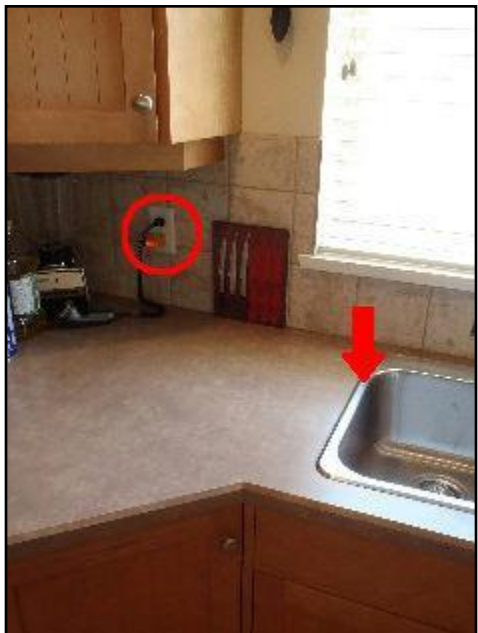
53. Ground Fault Interrupter (GFI) needed

Noted outlet close to kitchen sink is not a GFCI type outlet. It is recommend that all outlets within 3'-0" of a sink should be GFCI type outlets. Recommend changing outlet to a GFCI type.

Implication(s): Electric shock

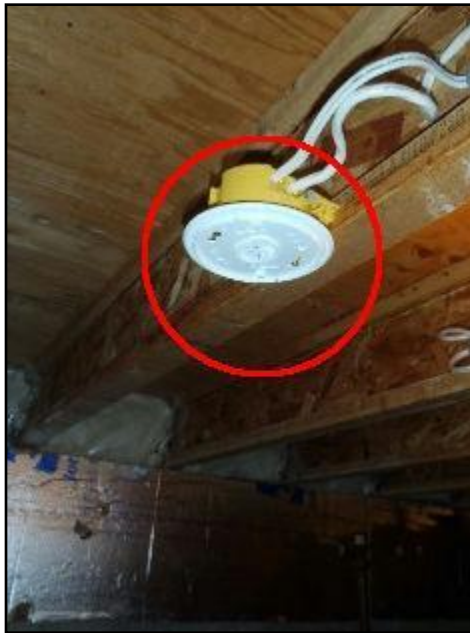
54. *Inoperative*

Noted smoke detector in crawl space has been removed. Recommend replacing existing or installing a new smoke detector (if supplying a new detector, a second detector maybe be needed as well. Hard wired smoke detectors need to communicate with each other so the need to be from the same manufacture and possibly the same model).

Implication(s): Fire hazard

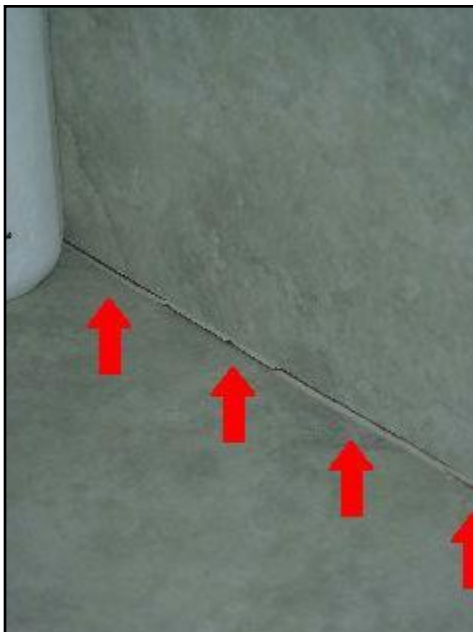
79. Caulking loose, missing or deteriorated

Noted caulking is in need of repair along shower stall bench or seat. Recommend adding caulking to help prevent water from damaging walls and flooring.

Implication(s): Chance of water damage to contents, finishes and/or structure

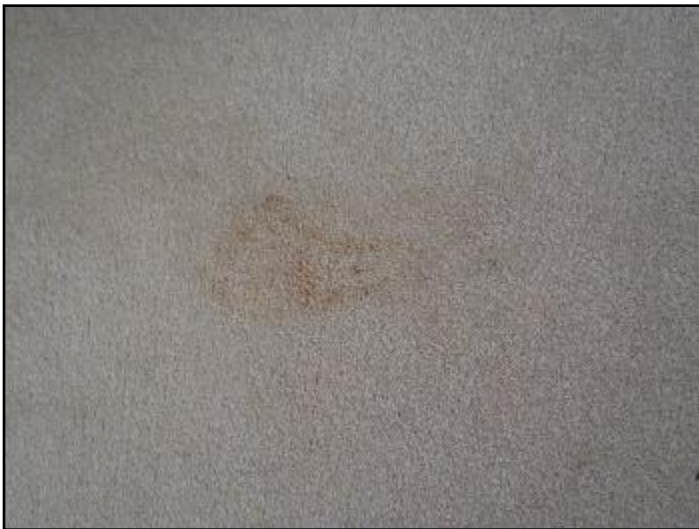
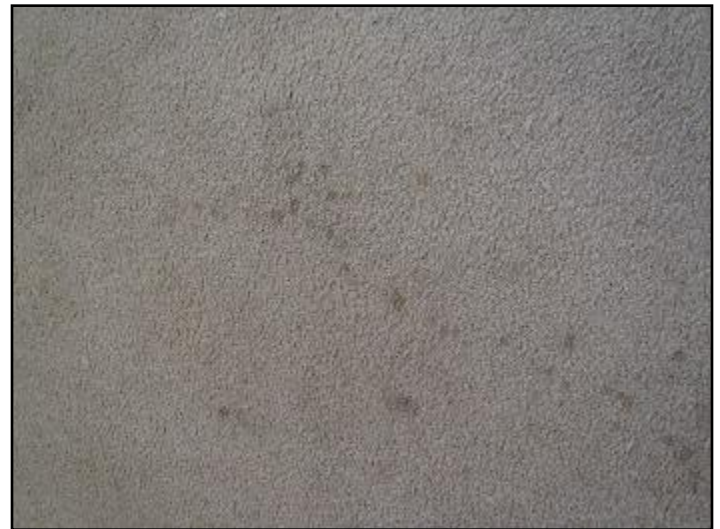
Noted stains on carpet in the master bedroom, hallway and living room.

Implication(s): Cosmetic defects

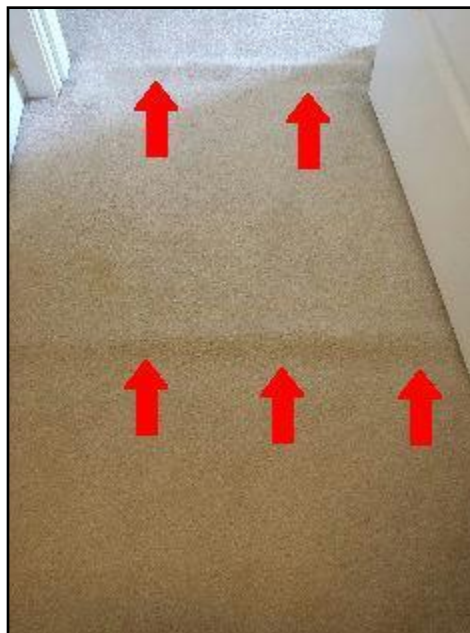
109. Buckled

Noted carpet in the spare bedroom was buckled. Recommend repairs

Implication(s): Cosmetic defects | Trip or fall hazard

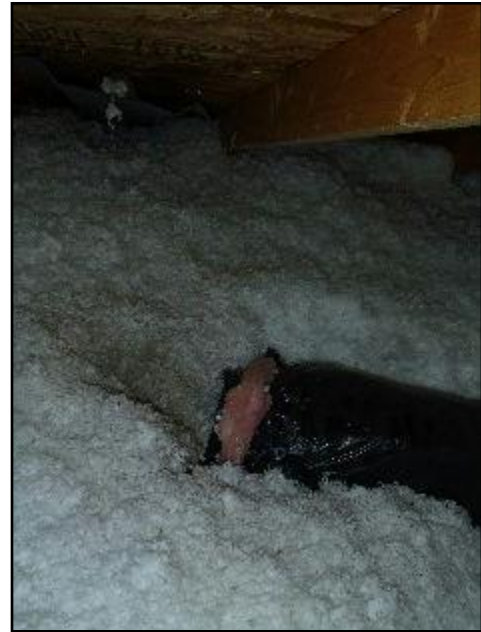
111. Not vented to exterior

Noted exhaust duct from main bathroom was not connected to roof vent at time of inspection. Inspector reconnected duct to roof vent while inspecting the attic. Recommend monitoring.

Implication(s): Chance of condensation damage to finishes and/or structure
