INSPECTION REPORT

For the Property at:
1234 MAIN ST
KELOWNA, BC

Prepared for: JOHN DOE
Inspection Date: Tuesday, March 11, 2014
Prepared by: Mike Bradshaw

RE: Report No. 1090, v.2
1234 Main St
Kelowna, BC

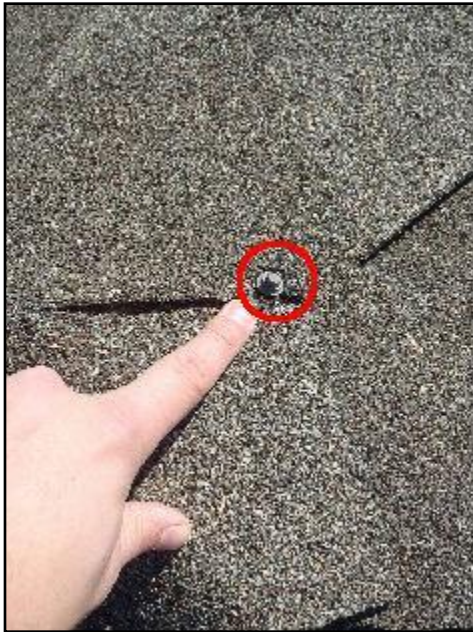
5. Exposed fasteners

Condition: • [Exposed fasteners](#)

Noted nail head popping up through asphalt shingle. Recommend repair and sealant added to nail head.

Implication(s): Chance of water damage to contents, finishes and/or structure

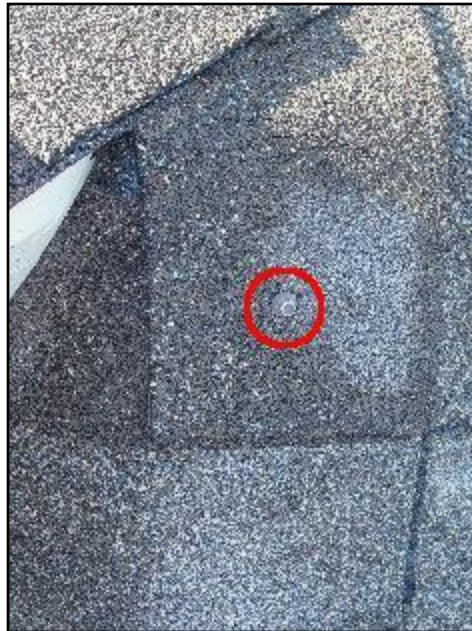
7. Exposed fasteners

Condition: • [Exposed fasteners](#)

Noted exposed screw heads in various locations on the roof, these nail heads should be tabbed with sealant to prevent rusting and leaks in the future.

Implication(s): Chance of water damage to contents, finishes and/or structure

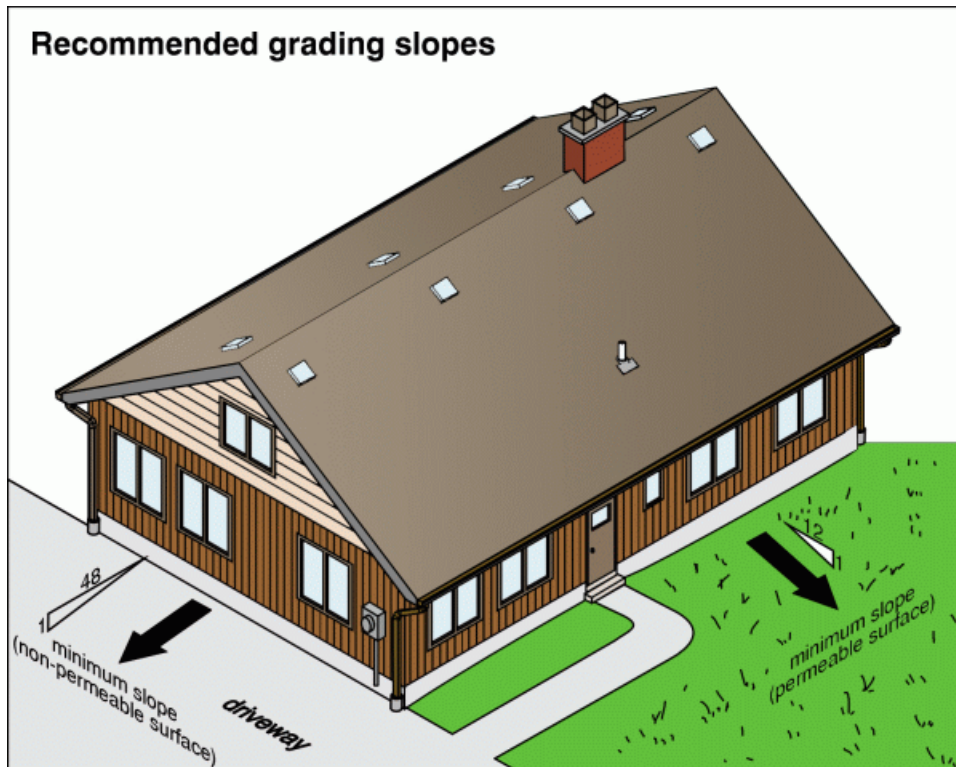
28. Improper slope or drainage

Condition: • [Improper slope or drainage](#)

Noted gravel walkway on the right side of the house slopes towards the foundation wall. Recommend sloping the soil against the foundation wall towards the gravel walkway. Crawl space inspection did not find any signs of moisture.

Implication(s): Chance of water damage to contents, finishes and/or structure

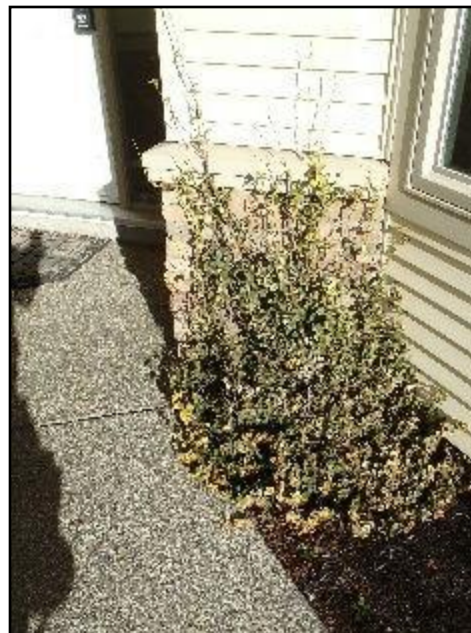
30. Vines on building

Condition: • Vines on building

Noted vine type plant growing in a few locations along the front of the house. Vines appear to be getting under vinyl siding. Recommend plants be removed or trimmed back to help avoid damage to the exterior siding.

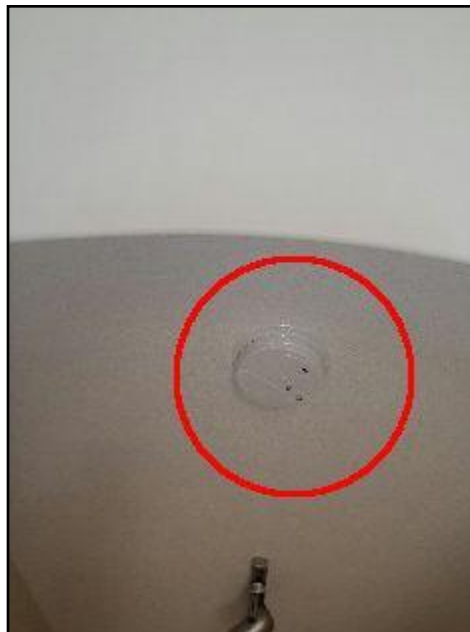
45. Present

Present on all levels of the home but not tested by inspector. Crawl space smoke detector had been disconnected and missing at time of inspection.

Noted smoke detector in crawl space has been removed. Recommend replacing existing or installing a new smoke detector (if supplying a new detector, a second detector maybe be needed as well. Hard wired smoke detectors need to communicate with each other so the need to be from the same manufacture and possibly the same model).

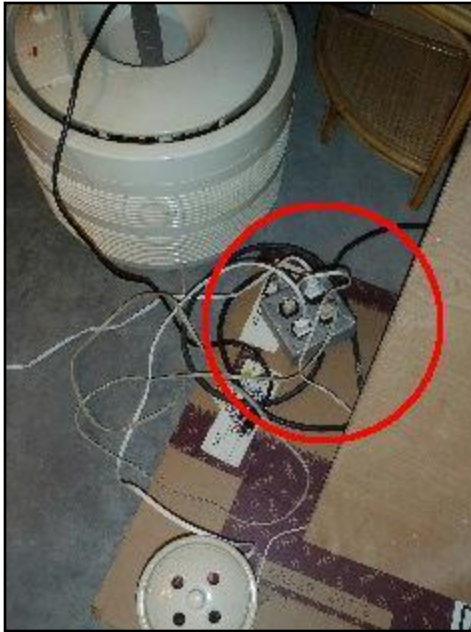
50.

11. Condition: • Noted several outlets in the crawl space that appeared to be overloaded with appliances, fans and heaters plugged into them. Recommend reducing the amount of appliances being used at the same time.

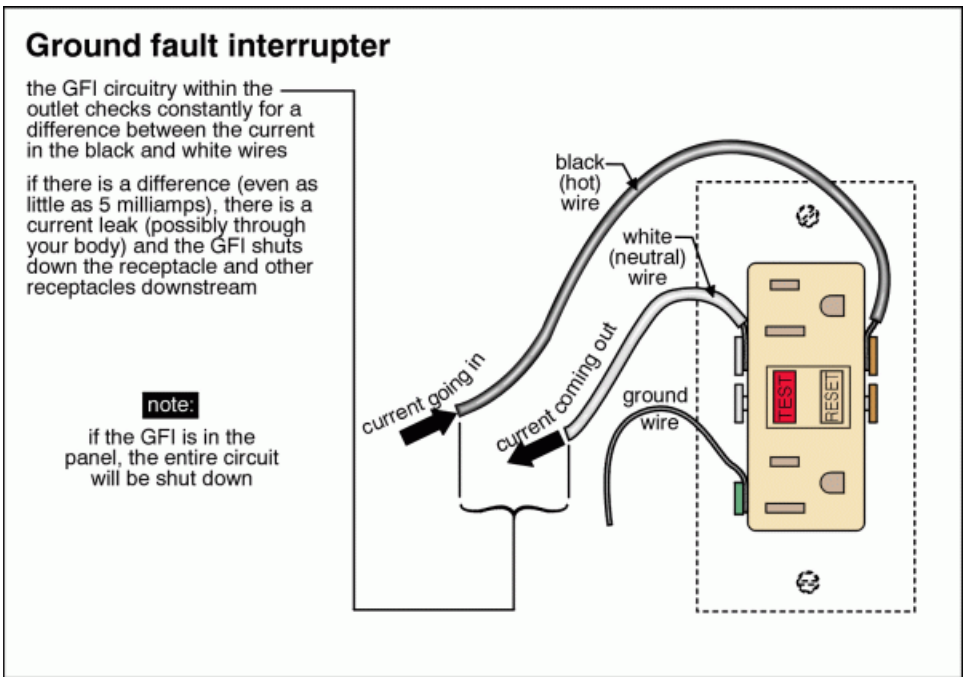
53. Ground Fault Interrupter (GFI) needed

Noted outlet close to kitchen sink is not a GFCI type outlet. It is recommend that all outlets within 3'-0" of a sink should be GFCI type outlets. Recommend changing outlet to a GFCI type.

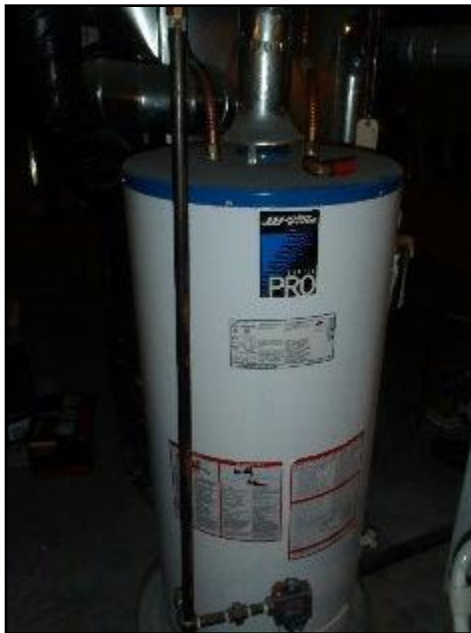
75. John Wood

Note: John Wood model - operational at time of inspection.

Due to the age of the water heater (10 years) the risk of failure is medium to high. Life expectancy is 8 to 12 years. This tank is nearing the end of its estimated life span. Recommend monitoring and plan on replacing 0 to 3 years.

As noted previously, the water heater is 10 years old and nearing the end of its recommended life span 8 -12 years. Recommend monitoring the tank and plan to replace in 0 to 3 years.

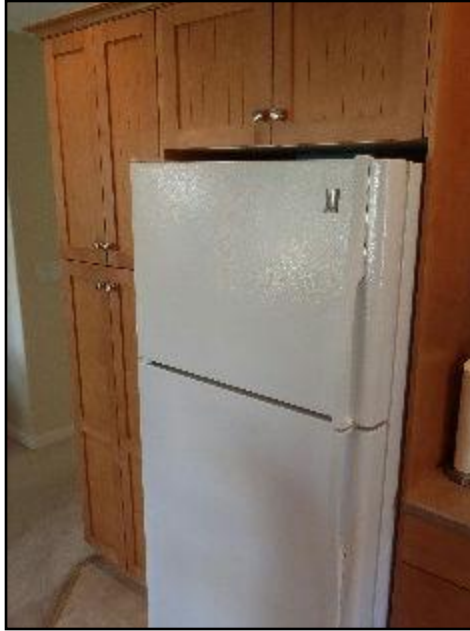
94. Refrigerator

GE model - operational at time of inspection

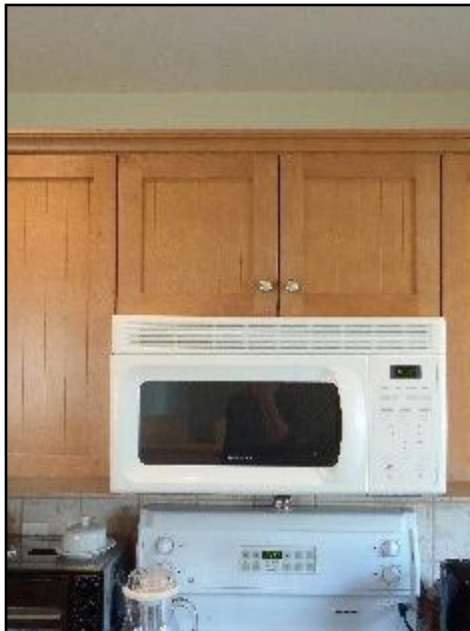
95. Range hood

Range hood / Microwave model - Samsung model - responded to controls

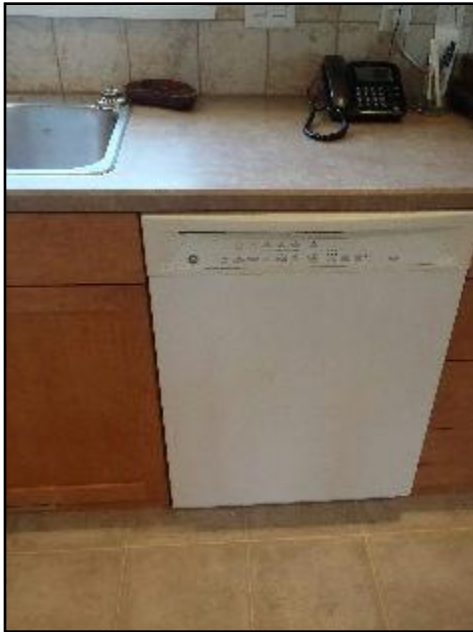
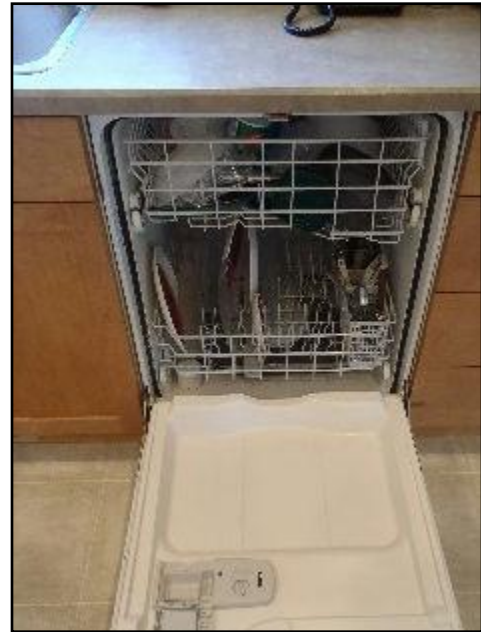
96. Dishwasher

GE model - not tested, dishes inside

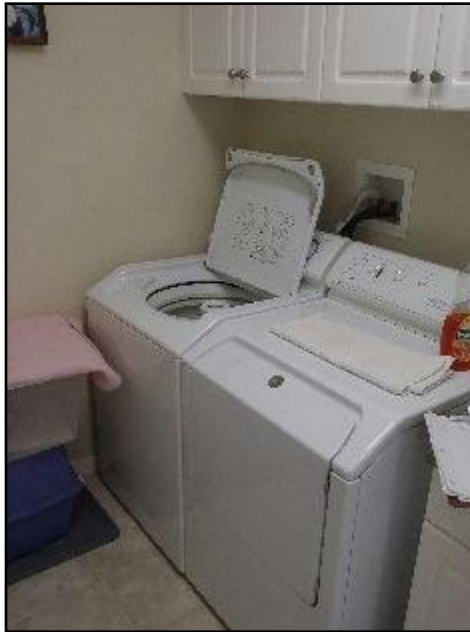
101. Washer

Maytag Model - Responded to controls, short cycle completed.

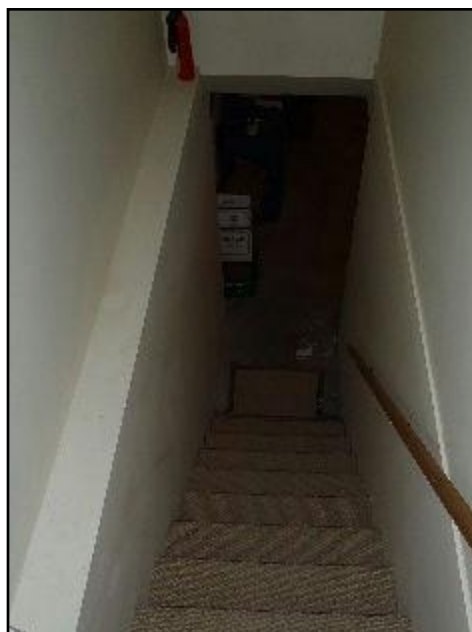
104. Inspected

- Inspected
Stairs to crawl space were inspected.

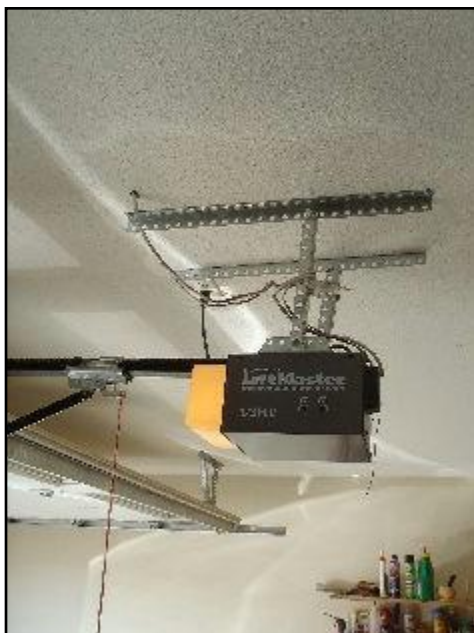
105. Chamberlain - Lift Master

Note: Garage door responded to switch and sensors.

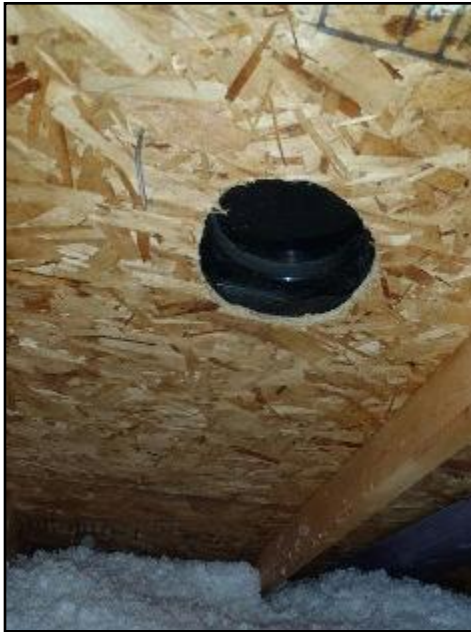
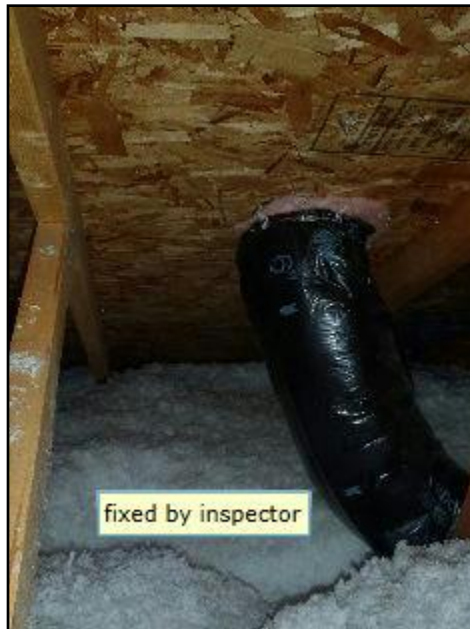
Noted exhaust duct from main bathroom was not connected to roof vent at time of inspection. Inspector reconnected duct to roof vent while inspecting the attic. Recommend monitoring.

Implication(s): Chance of condensation damage to finishes and/or structure

110. Not vented to exterior

112. Not vented to exterior

Task: Monitor

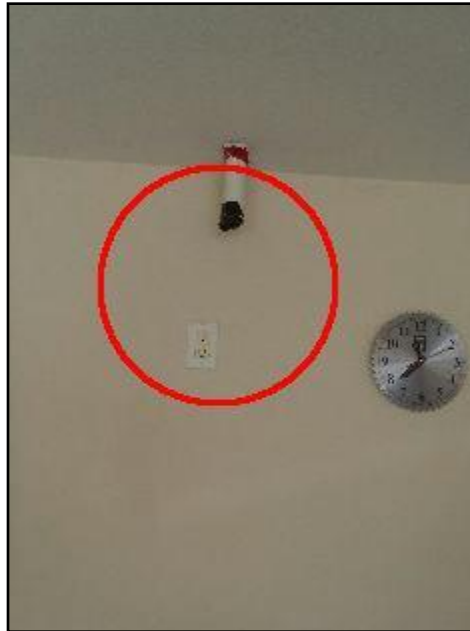
113.

22. Condition: • Noted vacuum was missing from built in vacuum system. The vacuum piping connection is located in the garage.

Task: Provide
